# Manhole Inspection Summary

Manhole # S02GG2004MH

**Location** Address: **3300 Clarks Ln**

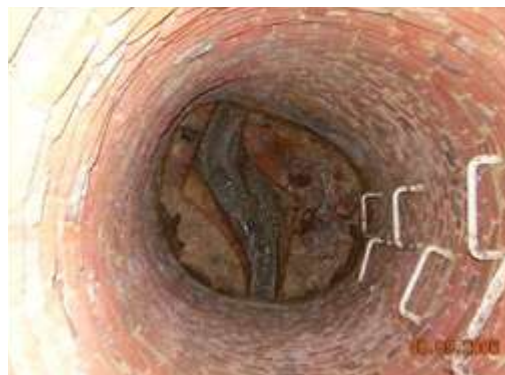
Top View

**Inspection** ☐ Is Incomplete Rating: **2) Good**

Condition: **Sound**

**Frame** Offset: **0** (in.) Condition: ☒ Sound ☐ Cracked ☐ Leaks

Condition: ☒ Sound ☐ Cracked ☐ Root Intrusion ☐ Loose Brick ☐ Deteriorated

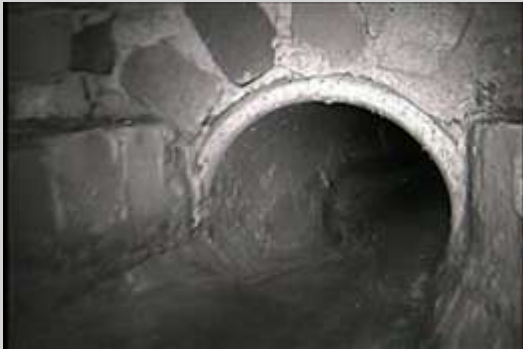
### 8 in. Circular Gravity Sewer Pipe Out @ 12 O'Clock

Pipe Material: **Clay** ☐ Pipe Lined

Invert Depth: **12.45** (ft.) Flow Characteristics: **Fast**

Deposits: ☒ None ☐ Mud ☐ Sludge ☐ Debris ☐ Grease

Infiltration: **None** Pipe Seal Cond: **Sound**

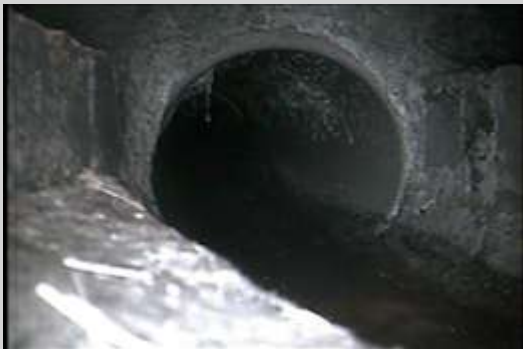
### 8 in. Circular Gravity Sewer Pipe In @ 5 O'Clock

Pipe Material: **Clay** ☐ Pipe Lined

Invert Depth: **12.15** (ft.) Flow Characteristics: **Fast**

Deposits: ☒ None ☐ Mud ☐ Sludge ☐ Debris ☐ Grease

Infiltration: **None** Pipe Seal Cond: **Sound**
